REPORT ON THE LARGE-SCALE FIRE PROPAGATION PROPERTIES OF 80 mm THICK EXPANDED POLYSTYRENE (FR GRADE) UNDER- ROOF AND SIDE CLADDING INSULATION MATERIALS USING THE SANS 10177-11 TEST METHOD

3. PURPOSE OF THE INVESTIGATION

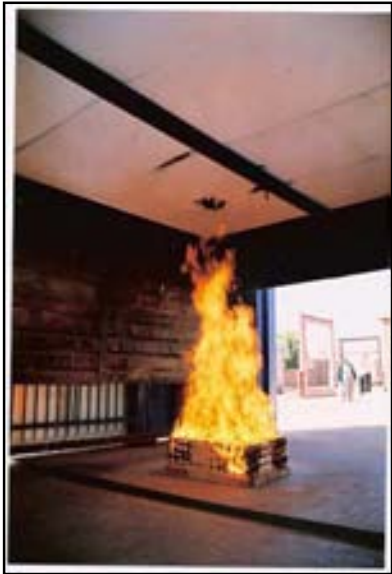
| Time (min:sec) | Observation |
|---|---|
| 4:17 | Deformation of material up to first purlin (2m) – no flaming. |

Figure B1-2: Material deforming and opening up in area above heat source (t = 4 min)

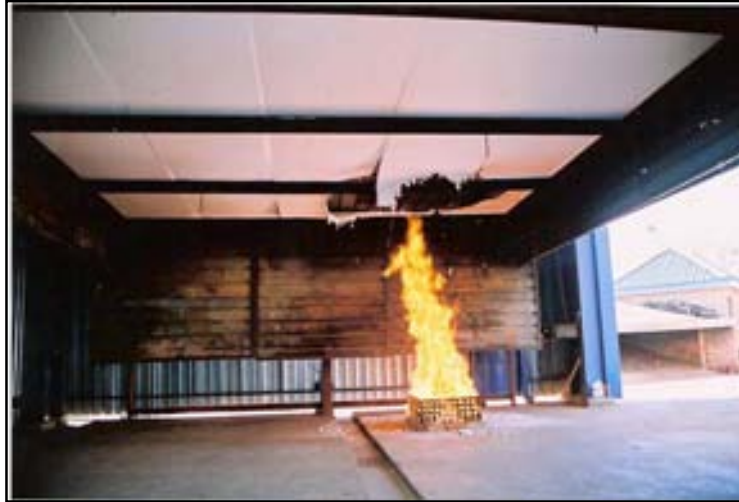
| Time (min:sec) | Observation |
|---|---|
| 8:23 | Material melted away up to first purlin with sheets of material starting to drop out. |

Figure B1-3: Larger area above fire source damaged but no ignition (t = 8 min)

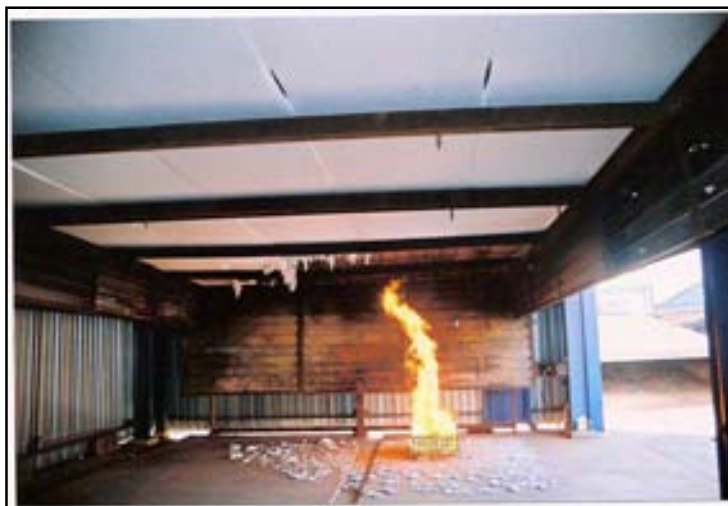
The evaluation also showed that no ignition of the insulation took place during the test and that the heat damage was limited to first four metres of the installation. Although all the material in the installation was pre-heated by the fire source, only shrinkage of the joints was visible on the second 6 m x 6 m panel of the test installation with the last 6 m x 6 m panel remaining undamaged.

Figure B1-4: Fire source decaying – no further spread of damage to installation (t = 15 min)

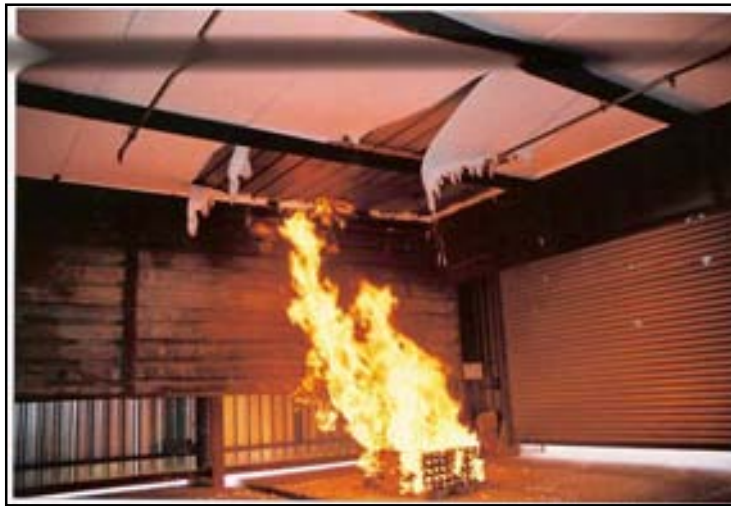
| Time (min:sec) | Observation |
|---|---|
| 3:08 | Deformation and melting of the material noted above the ignition source. |

Figure B2-2: Installation damaged in area above fire source (t = 5 min)

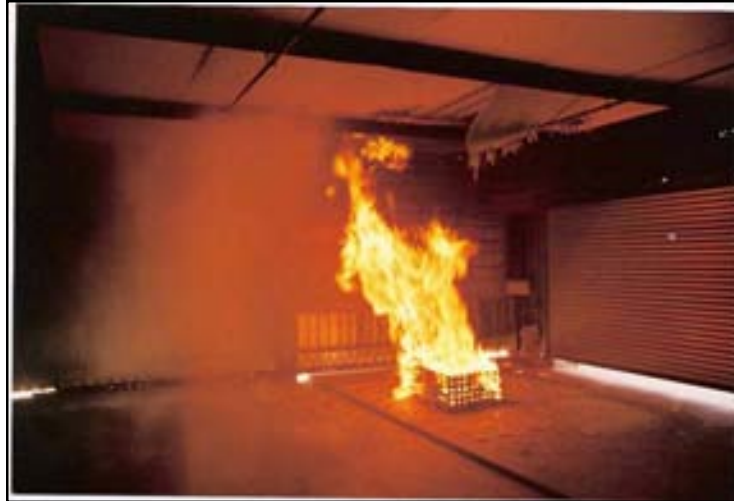
| Time (min:sec) | Observation |
|---|---|
| 7:26 | The first sprinkler activated. |

Figure B2-3: First sprinkler activated and operating unhindered (t = 7 min 30 s)

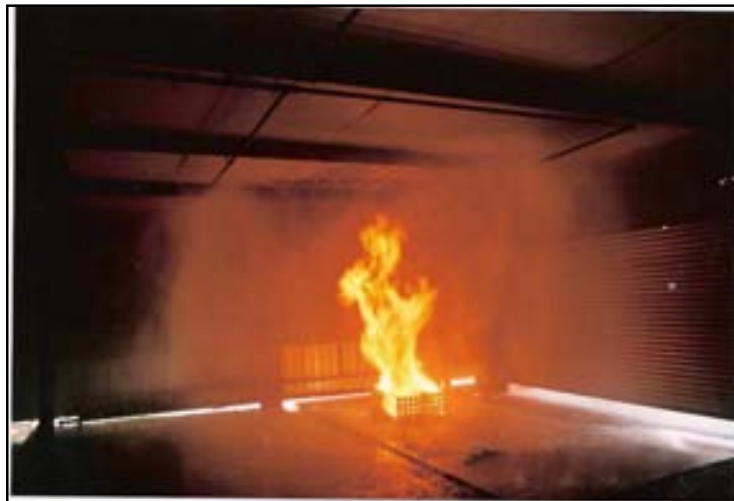
| Time (min:sec) | Observation |
|---|---|
| 9:37 | The second sprinkler activated. |

During the evaluation where a sprinkler system was installed, the damage to the material was notably less than during the evaluation without sprinklers. As before, no ignition of the material occurred. It can be stated, therefore, that the sprinkler activation decreased the heat damage to the insulation material. It was also shown that the insulation material did not affect the efficiency of the sprinkler installation.

Figure B2-4: Second sprinkler activated, no further damage to test installation (t = 9 min 30 s)

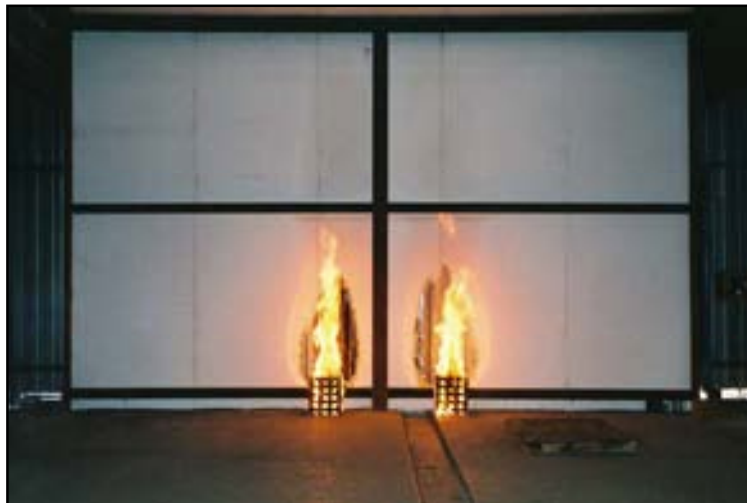
| Time (min:sec) | Observation |
|---|---|
| 4:27 | Deformation of material up to first horizontal purlin (2m high) with insulation material starting to open on the joint. |

Figure B3-2: Material deforming up to purlin on both sides (t = 5 min)

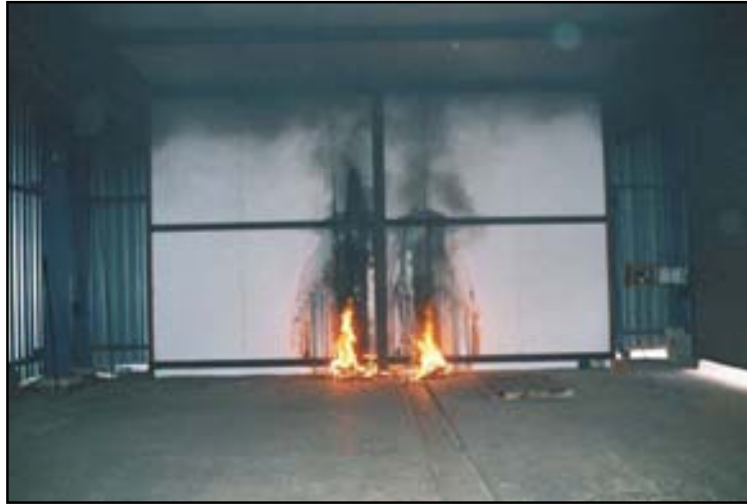
| Time (min:sec) | Observation |
|---|---|
| 18:36 | Flaming of the material noted between the bottom purlin and the IBR sheeting. |

The observations made during this assessment showed that the material is not likely to spread fire when installed in a vertical application. The only ignition or fire propagation resulted towards the end of the test when the timber cribs (ignition sources) collapsed against and on top of the insulation material that dropped down during the test. The fire damage was limited to less than a metre above the floor, which can be regarded as negligible. Should a sprinkler system be installed, as would be the case in many buildings, no ignition of the material is likely to have occurred.

Figure B3-3: Starter packs collapsed against installation with some fallen material burning between bottom purlin and IBR sheeting (t = 19 min)

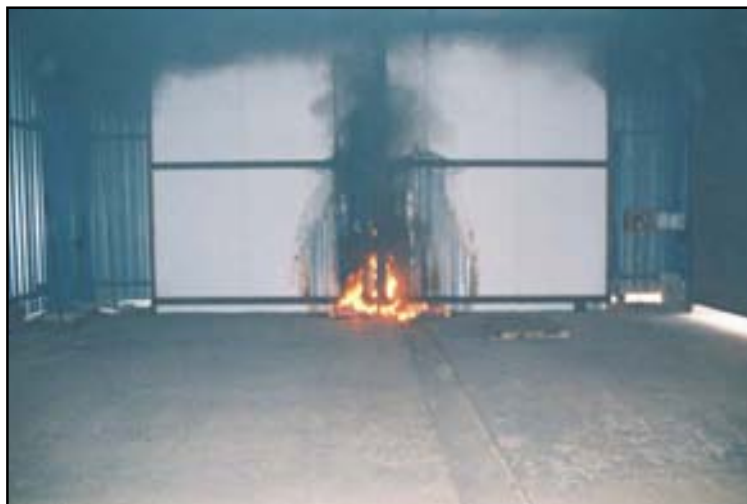
| Time (min:sec) | Observation |
|---|---|
| 22:00 | Slight vertical flame spread between the collapsed ignition sources and the vertical support element noted. Flaming was limited to approximately 1m above the ignition source |

Figure B3-4: Limited flaming along vertical support element (t = 22 min), which seized at t = 24 min)

Although the material can be safely utilised in side cladding applications from a fire point of view, it is recommended that no insulation be installed at low levels in order to avoid subsequent damage that may occur in any building. In instances where racking and shelving are present, side cladding insulation should generally not be fitted below a metre above the maximum stacking height. Although the above comment is not a requirement as such, consideration should always be given to the use, occupancy and contents of a specific building structure. A good fire safety design should address this issue however.
